# Manhole Inspection Summary

Manhole # S1500\_001MH

Insp Date: **7/14/09 9:08 AM**

**Location** Address: **2703 GWYNNS FALLS PKWY**

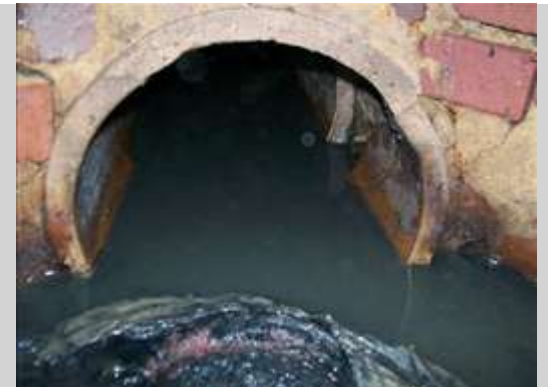
Drop In @ 4 O'Clock

Deposits: ☐ None ☐ Mud ☒ Sludge ☒ Debris ☒ Grease

Silt Depth: **8** (in.) Deposits Extent: **Heavy**

Drop: **Outside Direct**

Drop Condition: **Clogged**
